Inspection Report Exclusively For: 15-25 Years Old-072706

FILE/DATE/TIME File # 15-25 year old Date: 07/27/06 Time: 3:00 PM.
CLIENT NAME Your Name Here.
LOCATION 123 Main, Newport Beach, CA 92680.

MAIN ENTRY	Faces: South.
DESCRIPTION	Reportedly 21 years old, 2 story, reportedly 3000 square Ft. condominium unit.
FOUNDATION	Foundation types: concrete slab on grade.

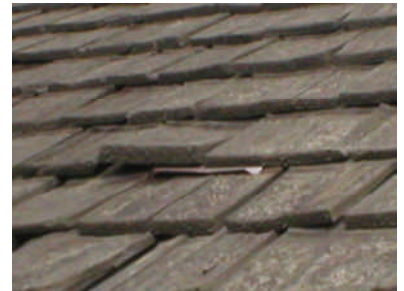
[FE] There were a number of wood shakes that were damaged, deteriorated.

[SC] There were metal repair/replacement shingles noted.

[FE] The roof appeared old and showed signs of advanced deterioration.

[CR] Trees were touching/over hanging the roof. We recommend they be trimmed and the debris removed to prevent damage to the roof and to prevent animal access.

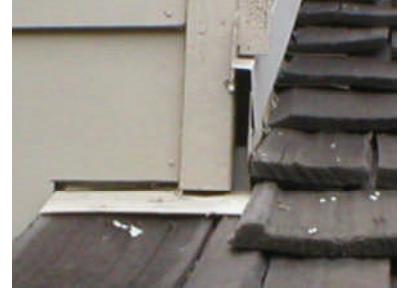
[FE] There are unsealed flashings noted at roof to wall intersection(s).

[CR] Some of the flashings were rusty. Debris noted behind chimney. We recommend they be cleaned, painted and/or replaced as needed.

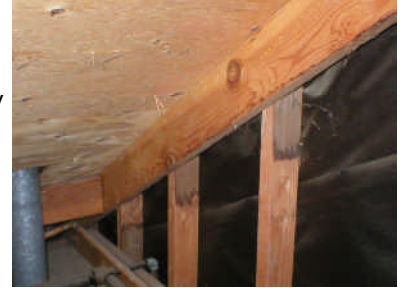
406 ROOF FRAMING	[FE] Moisture stains were noted on the roof framing. [FE] Area above garage converted for storage. We recommend verification and approval of installation by a licensed structural engineer.
------------------	---

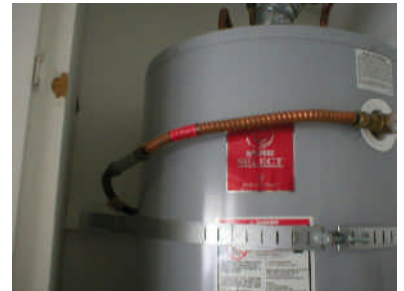
- 535 **"T & P" VALVE(S)** [SC] The temperature & pressure relief valve discharge line was routed in a material that was not rated for this application, [flex copper]. We recommend installing an approved discharge line that extends to the exterior and terminates close to the ground facing downward.

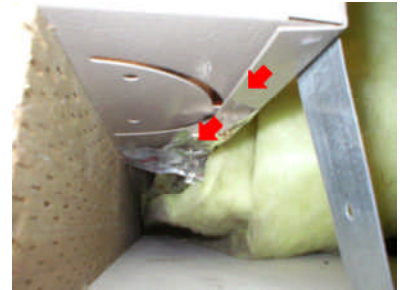
707 SUPPLY PLENUM(S) [CR] There were air leaks and conditioned air was escaping.

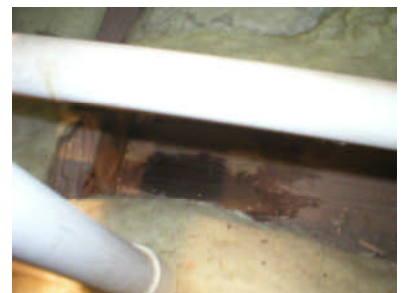
[CR] There were moisture stains on the platform under the air conditioning section of the furnace. The stains are wet at this time. We recommend locating and correcting the source and any damaged materials.

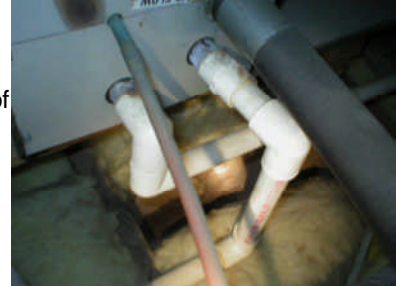
[FE] Gas heaters with electric air conditioning: We recommend installing a trap and vent on the primary condensate drain line to prevent the loss of conditioned air and to guard against the introduction of contamination into the system. Traps and vents are required by various manufacturers but not all. Compliance to specific manufacturers' specifications is beyond the scope of our inspection. To determine if a trap and vent is required we recommend further evaluation by a factory qualified technician of this specific manufacturer.

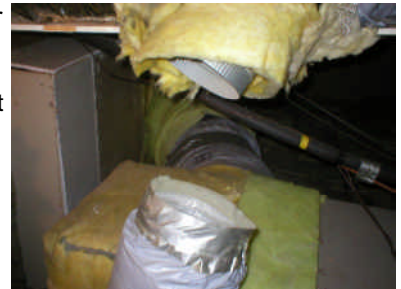
[CR] The outer plastic covering on the conditioned air ducts was deteriorated.

[CR] There were conditioned air ducts in the attic that have come apart.
