Inspection Report Exclusively For: 15-25 Years Old-072706

FILE/DATE/TIME File # 15-25 year old Date: 07/27/06 Time: 3:00 PM.
CLIENT NAME Your Name Here.
LOCATION 123 Main, Newport Beach, CA 92680.

MAIN ENTRY	Faces: South.
DESCRIPTION	Reportedly 21 years old, 2 story, reportedly 3000 square Ft. condominium unit.
FOUNDATION	Foundation types: concrete slab on grade.

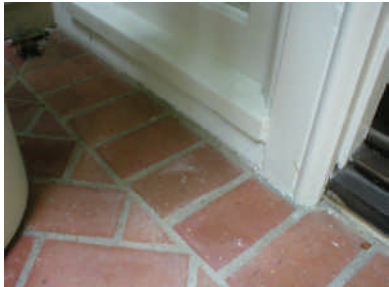
223 MAIN ENTRY	<p>[FE] The entry/porch surface is against the bottom edge of the wood siding, this condition is conducive to moisture intrusion and deterioration of the wall.</p>

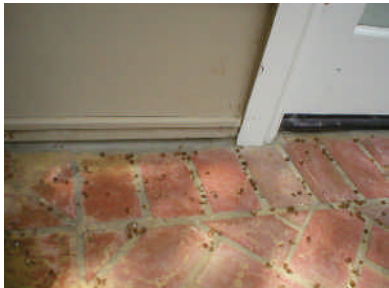
224 PATIO(S)	<p>[FE] The patio surface was against the bottom edge of the manufactured wood siding wall. This condition is conducive to moisture intrusion and deterioration of the wall.</p>

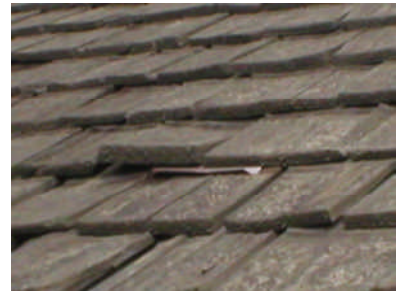
[FE] There were a number of wood shakes that were damaged, deteriorated.

[SC] There were metal repair/replacement shingles noted.

[FE] The roof appeared old and showed signs of advanced deterioration.

[CR] Trees were touching/over hanging the roof. We recommend they be trimmed and the debris removed to prevent damage to the roof and to prevent animal access.

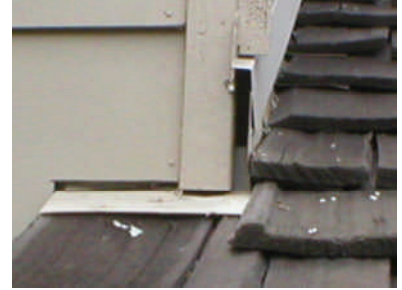
[FE] There are unsealed flashings noted at roof to wall intersection(s).

[CR] Some of the flashings were rusty. Debris noted behind chimney. We recommend they be cleaned, painted and/or replaced as needed.

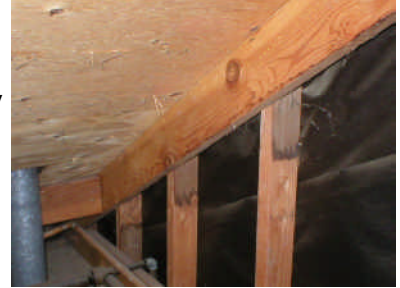
406 ROOF FRAMING	[FE] Moisture stains were noted on the roof framing. [FE] Area above garage converted for storage. We recommend verification and approval of installation by a licensed structural engineer.
------------------	---

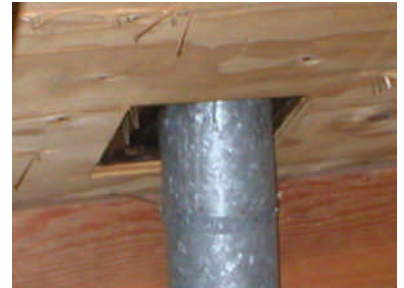
- 533 **VENTING SYSTEM(S)** [SC] The flue vent pipe was not secured at connections as required.
- [SC] The flue vent piping was close to combustible materials in attic. This condition is a fire hazard.

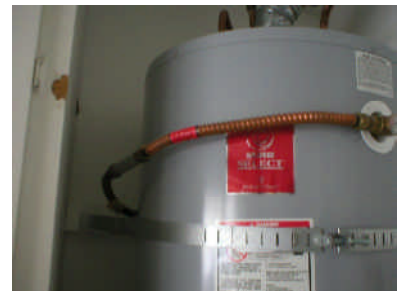
- 535 **"T & P" VALVE(S)** [SC] The temperature & pressure relief valve discharge line was routed in a material that was not rated for this application, [flex copper]. We recommend installing an approved discharge line that extends to the exterior and terminates close to the ground facing downward.

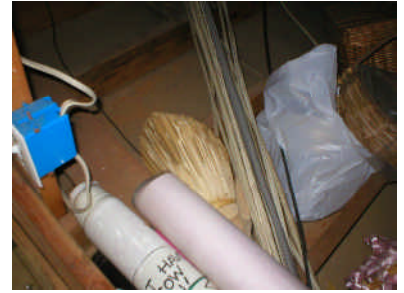
622 CIRCUIT WIRING

[SC] The exposed wiring within six feet of the attic access opening was not protected from damage.

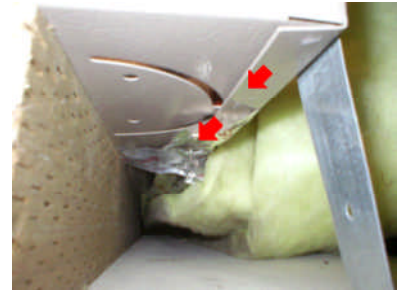
707 SUPPLY PLENUM(S) [CR] There were air leaks and conditioned air was escaping.

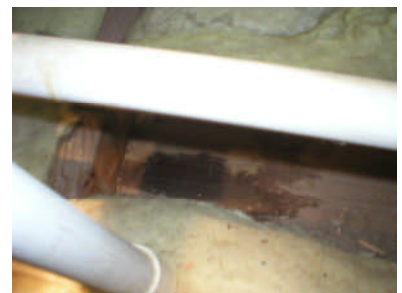
[CR] There were moisture stains on the platform under the air conditioning section of the furnace. The stains are wet at this time. We recommend locating and correcting the source and any damaged materials.

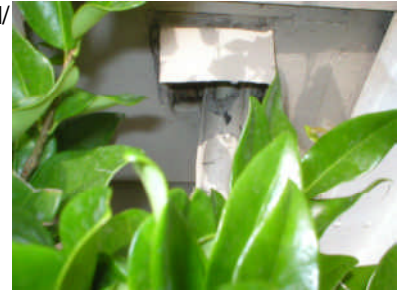
[CR] The coolant lines were not sealed to the wall where they entered the building. This condition allows for rodent access.

[CR] Vegetation was growing around the condensing unit. This condition is conducive to deterioration of the unit and reduces the overall performance.

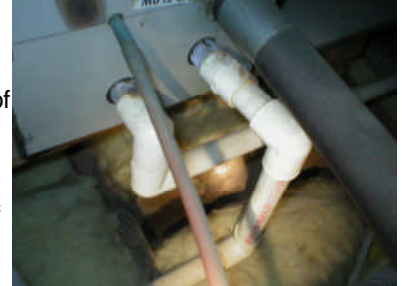
[FE] Gas heaters with electric air conditioning: We recommend installing a trap and vent on the primary condensate drain line to prevent the loss of conditioned air and to guard against the introduction of contamination into the system. Traps and vents are required by various manufacturers but not all. Compliance to specific manufacturers' specifications is beyond the scope of our inspection. To determine if a trap and vent is required we recommend further evaluation by a factory qualified technician of this specific manufacturer.

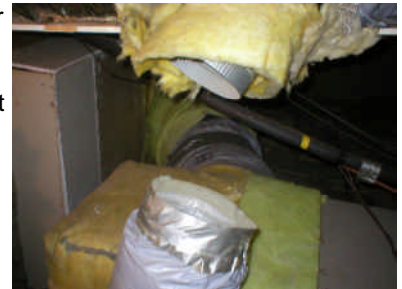
[CR] The outer plastic covering on the conditioned air ducts was deteriorated.

[CR] There were conditioned air ducts in the attic that have come apart.

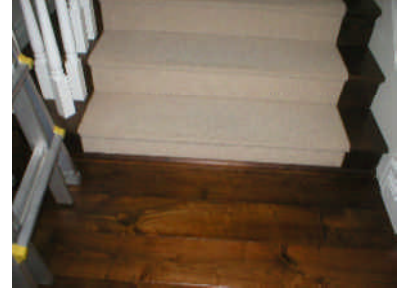
[SC] There was improper rise on stairs, this condition is a trip hazard.

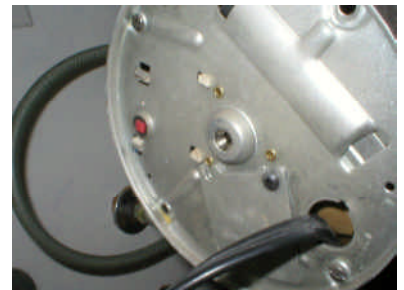
[SC] The power cord/wiring was not clamped to the disposal as required.
