FILE/DATE/TIME File # Sample-082707 ASHI Date: 08/27/07 Time: 11:30 AM.
CLIENT NAME ASHI Sample.
LOCATION 123 Main St., Lakewood, CA.

MAIN ENTRY Faces: East.
STRUCTURE Reportedly built 1949, 1 story, reportedly 1005 square Ft. single-family residence.
FOUNDATION Foundation types: raised foundation.

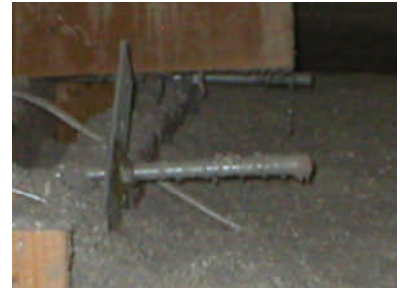
- 319 ROOF FRAMING [FE] Framing has been modified in several locations. We recommend verification of modifications by the appropriate professional.

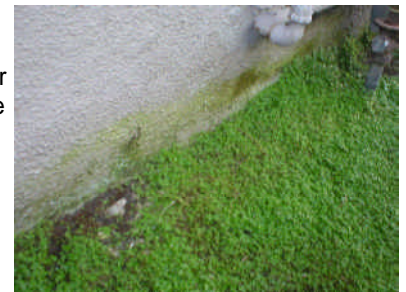
402 STUCCO CLADDING	[CR] This building was built in an era before weep screeds were installed at the bottom edge of the stucco siding, the stucco was extended into the soil or grade. The stucco wicks water up out of the soil. We recommend minimizing moisture around the building to help protect the stucco and the foundation from moisture damage.
---------------------	--

[CR] The stucco siding had moisture damage/deterioration at several locations of the building. These conditions are conducive to moisture intrusion/deterioration.

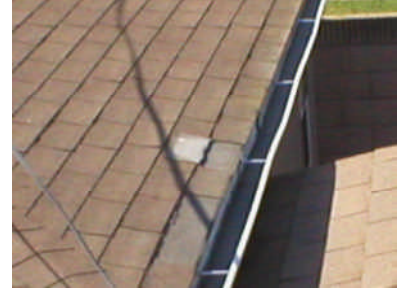
[FE] Improper drip edge configuration. Evidence of ponding water noted.

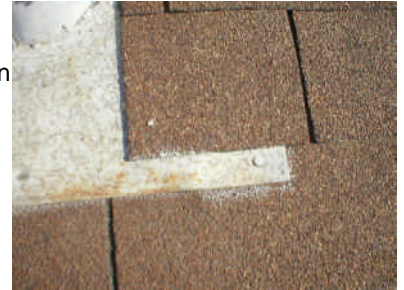
[CR] There were substandard or missing flashings at garage rear.

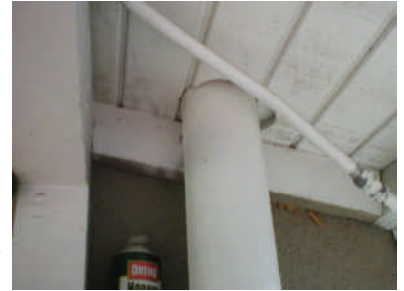
[SC] Substandard vent installation.

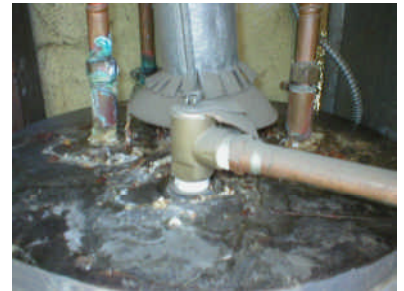
[CR] The water heater tank was leaking. We recommend correcting the condition(s) noted.

[FE] The metal casing of the water heater tank was corroded/deteriorated. We recommend a full evaluation and/or corrections by an appropriate professional in the appropriate trade.

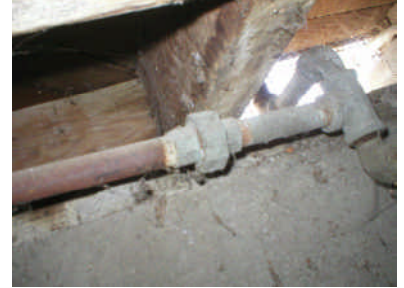
- 631 GAS SHUTOFF [RU] The supply shutoff appeared functional, we do not operate these devices. There is no emergency shutoff wrench present. We recommend providing a wrench or installing a seismic automatic shut off valve for emergencies.
- 632 GAS PIPING [SC] Improper use of gas pipe union in attic space and crawl space. We recommend correcting the condition(s) noted.
- [CR] Areas of the visible gas piping were damaged/deteriorated. We recommend correcting the condition(s) noted.
- [CR] Areas of the visible gas piping lacked adequate corrosion protection where passing through ground/hardscaping. We recommend correcting the condition(s) noted.

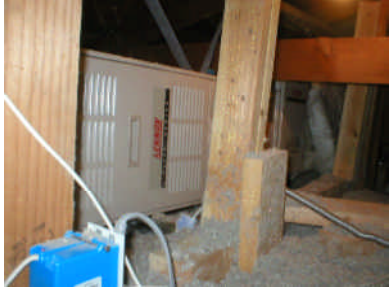
- [FE] There was insufficient work space in front of the equipment. We recommend correcting the condition(s) noted.
- [FE] Substandard installation
-

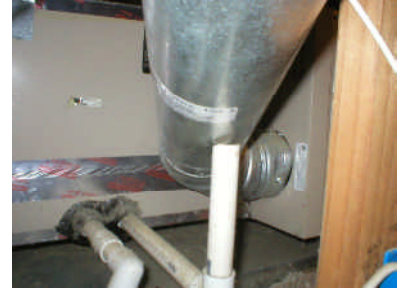
[SC] The flue vent piping was in contact with combustible materials, this condition is a fire hazard. We recommend correcting the condition(s) noted.

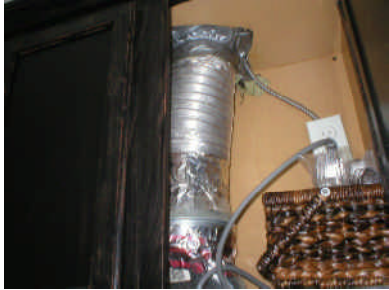
- 1301 COOKTOP(S) The cooktop/range burners functioned with exceptions noted.
- [SC] The range/oven lacked an anti-tip device at the rear as required. This condition is a topple hazard. We recommend correcting the condition(s) noted.
- 1302 OVEN(S) The oven functioned.
- 1304 MICROWAVE(S) The microwave oven functioned and heated a wet rag.
- 1305 EXHAUST VENT(S) The exhaust fan(s)/ light(s) functioned
- [SC] The visible portion of the exhaust vent ducting was a corrugated flexible material, these products were not approved for kitchen exhaust vents. We recommend correcting the condition(s) noted.
-
